Feasibility of mitigating physical disturbances to eelgrass in northern Casco Bay: Impacts and Options

Prepared by

**MER Assessment Corporation
14 Industrial Parkway
Brunswick, Maine 04011
207-798-7935 (V)
207-729-4706 (F)
207-751-3696 (C)
mer@maine.com**

28 February 2008

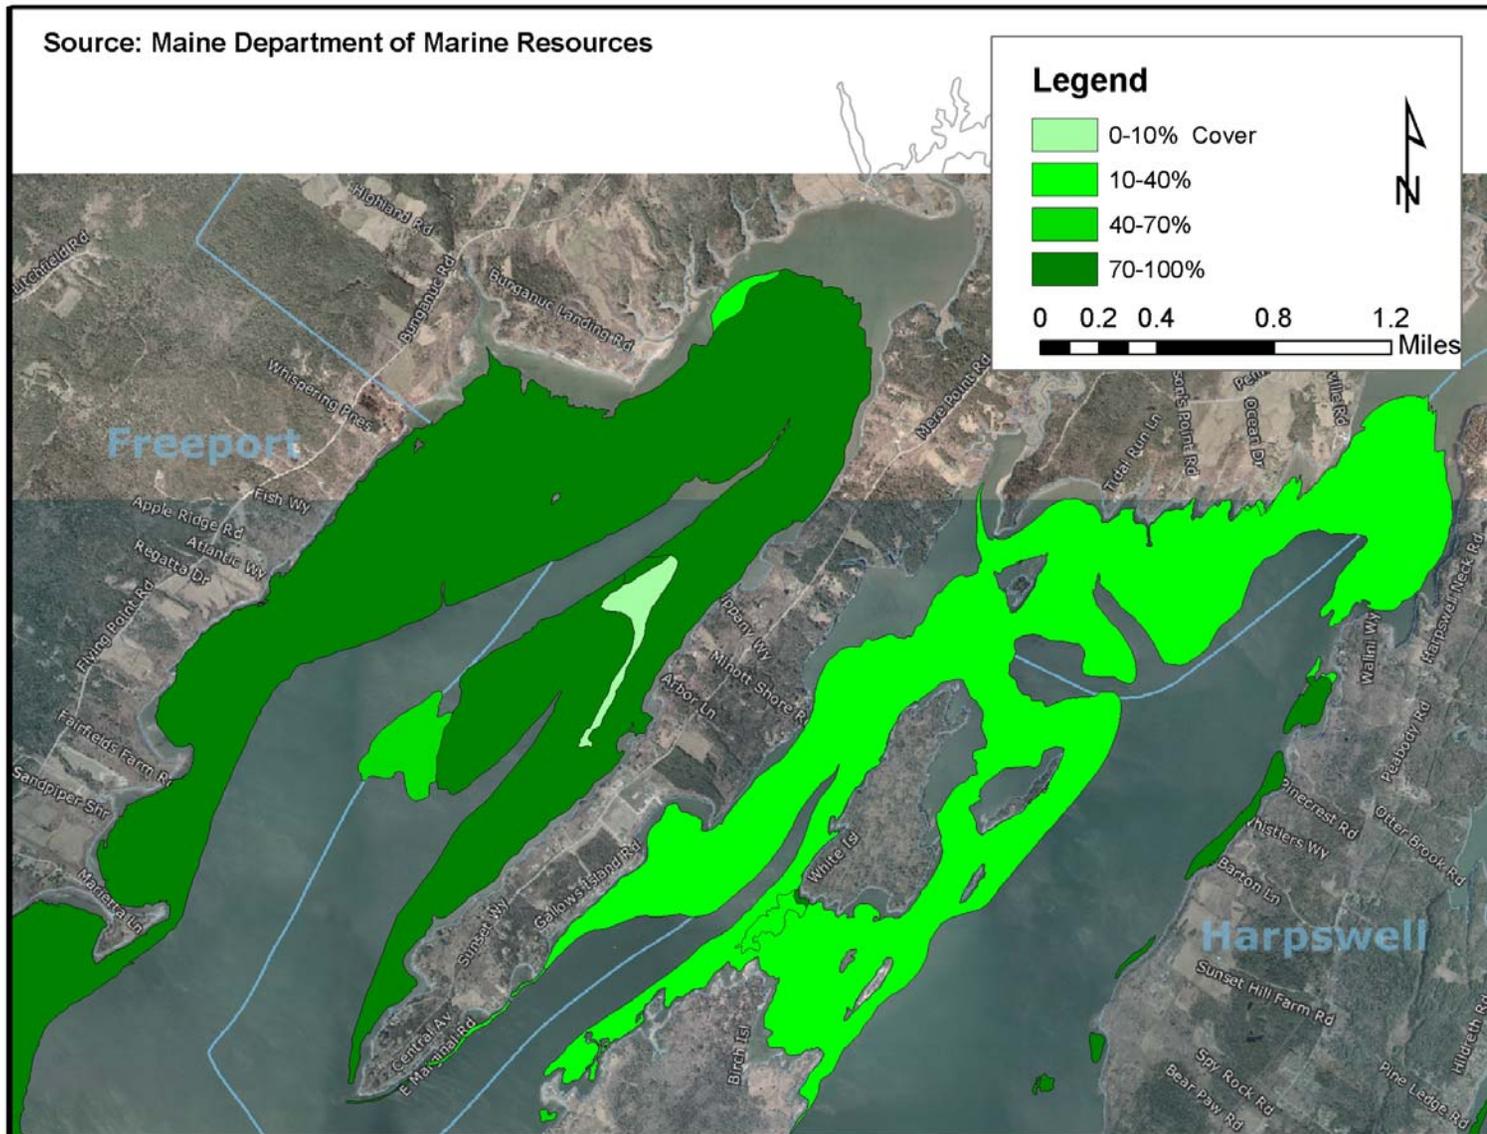
Figure 1 Distribution of eelgrass in northern Casco Bay based on interpretation of 2001-02 aerial photographs (Seth Barker, Maine DMR).

Eelgrass in northern Casco Bay covers much of the lower intertidal and shallow subtidal areas to a depth of approximately 3 m (Neckles et al, 2005); eelgrass distribution in northern Casco Bay has fluctuated over the years. Working in Maquoit Bay, Neckles et al. (2005) calculated annual coverage increases and decreases of 27.5 hectare (ha) and 4.4 ha, respectively, for the period 1993 to 2000 (net annual increase of 23.1 ha), and 37.2 and 2.6, respectively, for the period 2000-2001 (net annual increase of 34.6 ha). They also estimated the area of eelgrass cover in Maquoit Bay as of 2001 at 570.1 ha (1,408.7 ac). No similar estimate has been made of the eelgrass cover in Merepoint and upper Middle Bay, but similar expansion of the eelgrass coverage in these areas has occurred and appears to be at least half the area covered in Maquoit Bay, as shown in Figure 1; if so, eelgrass cover within northern Casco Bay would be approximately 805 ha (1,990 ac). According to Seth Barker of the Maine Department of Marine Resources (DMR) GIS and habitat mapping office, eelgrass in the northern Casco Bay region is at or near its maximum areal distribution.

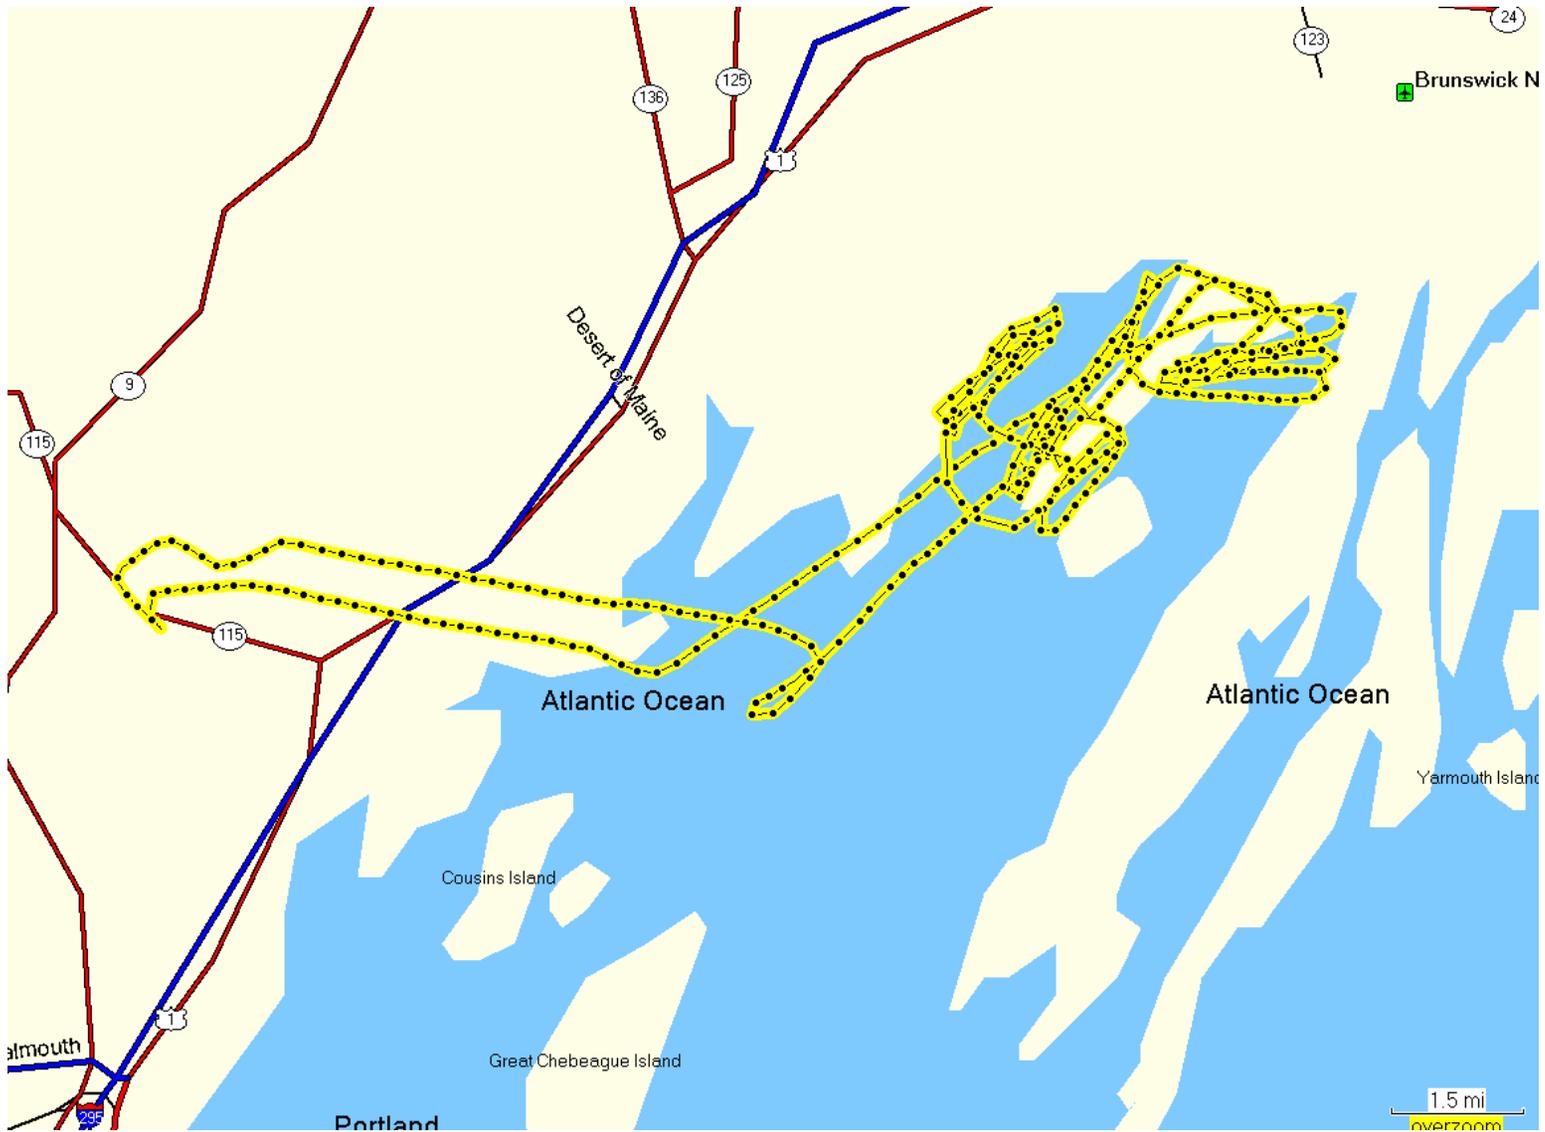
Figure 2 Flight path of August 30, 2007 aerial photography.

An effort was therefore undertaken to produce a new series of lower altitude aerial photos that would allow a more detailed and up-to-date view of physical damages to eelgrass. To accomplish this, vertical aerial photographs were taken from an Aeronca 7AC aircraft in level flight attitude between 06:20 to 06:50 on August 30, 2007. On that date, a -0.9 ft. low tide at Flying Point, Freeport was predicted to occur at 06:48. A Nikon D70 35mm digital camera equipped with a Nikon 18-55mm f/3.5 - 5.6G lens was strut mounted and controlled through a USB 2.0 cable attached to an IBM T43 ThinkPad using Nikon Camera Control Pro software. Focus was fixed with tape at infinity. Focal length was set at 35 mm resulting in an equivalent focal length of 53 mm for minimal distortion. Aperture speed was 1/200th second with aperture varying depending on light, typically f 5.6. Altitude flown was 2,600 ft. MSL +/- 100 ft. Airspeed was held at 75 mph with groundspeed varying between 65 and 85 mph with a 10 mph tail/headwind. Position and altitude for photography was independently tracked at 10 second intervals using a handheld Garmin GPS 60; flight path is shown in Figure 2. Additional flights to increase aerial photo coverage were planned, but were constrained by the need to coordinate tide height with time of day for proper light (early morning), weather, water clarity, and access to restricted air space around the Brunswick Naval Air Station approach.

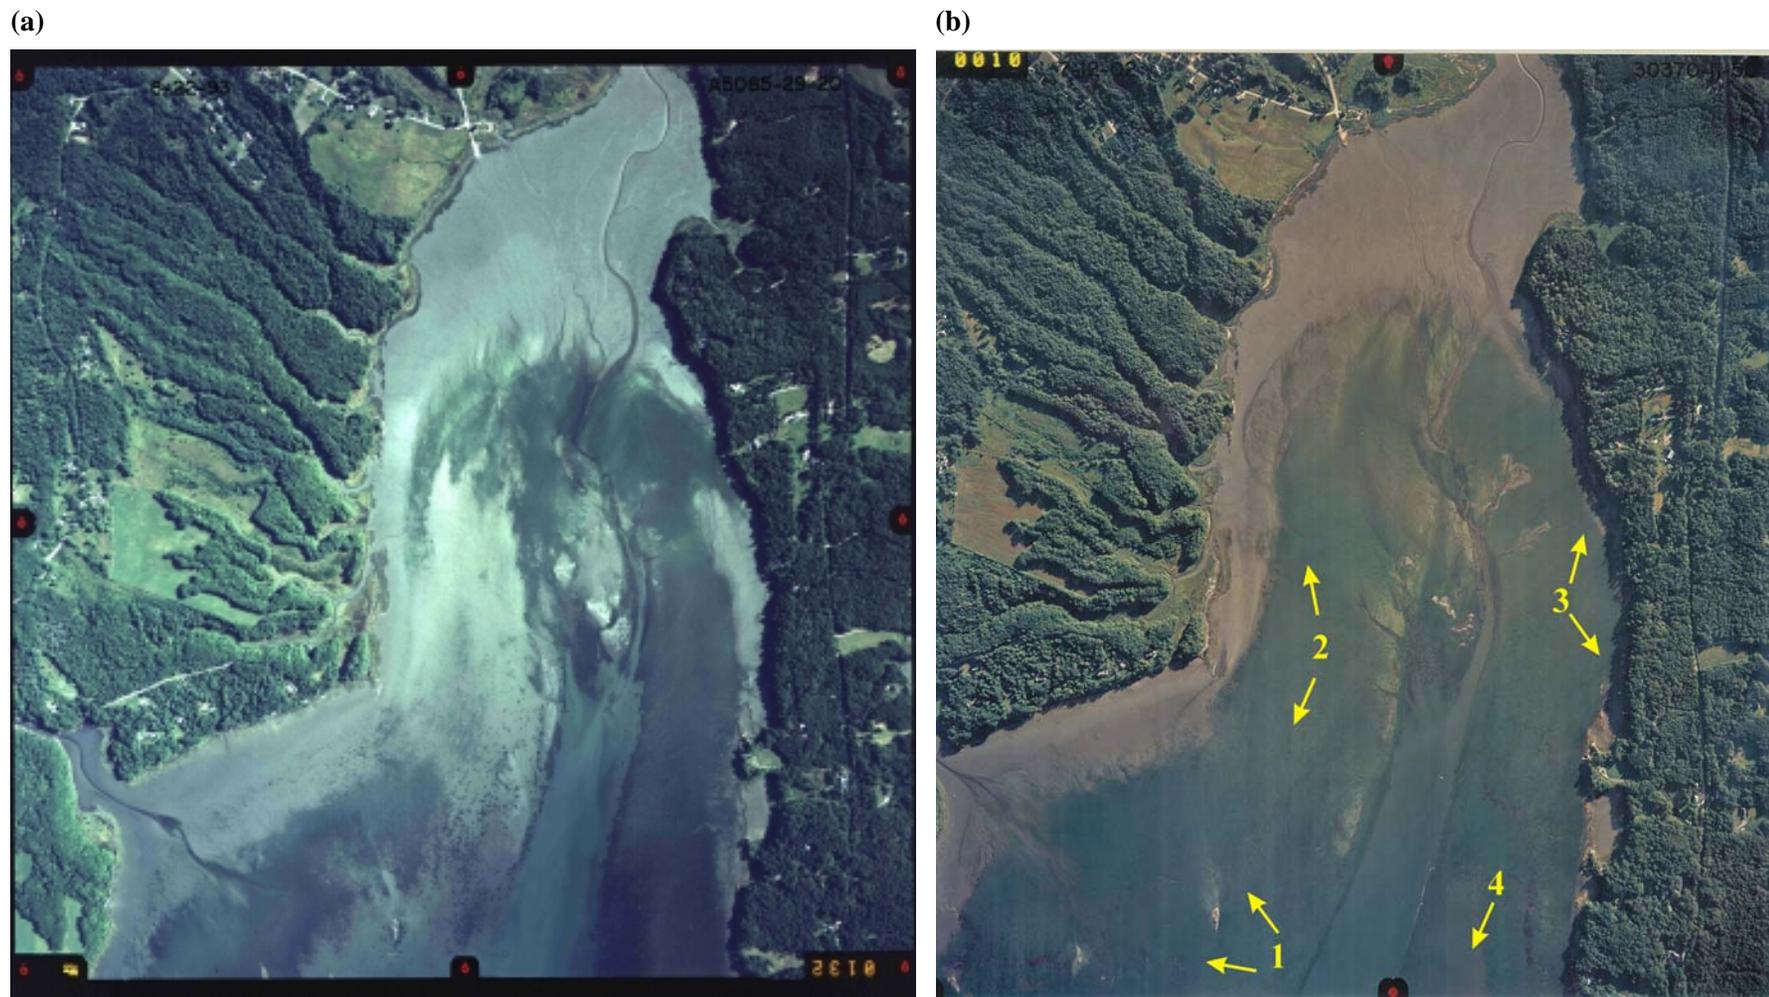
Figure 3 Aerial photos of upper portion of Maquoit Bay taken in 1993 (a) and 2001 (b) showing extent of expansion of eelgrass over the period

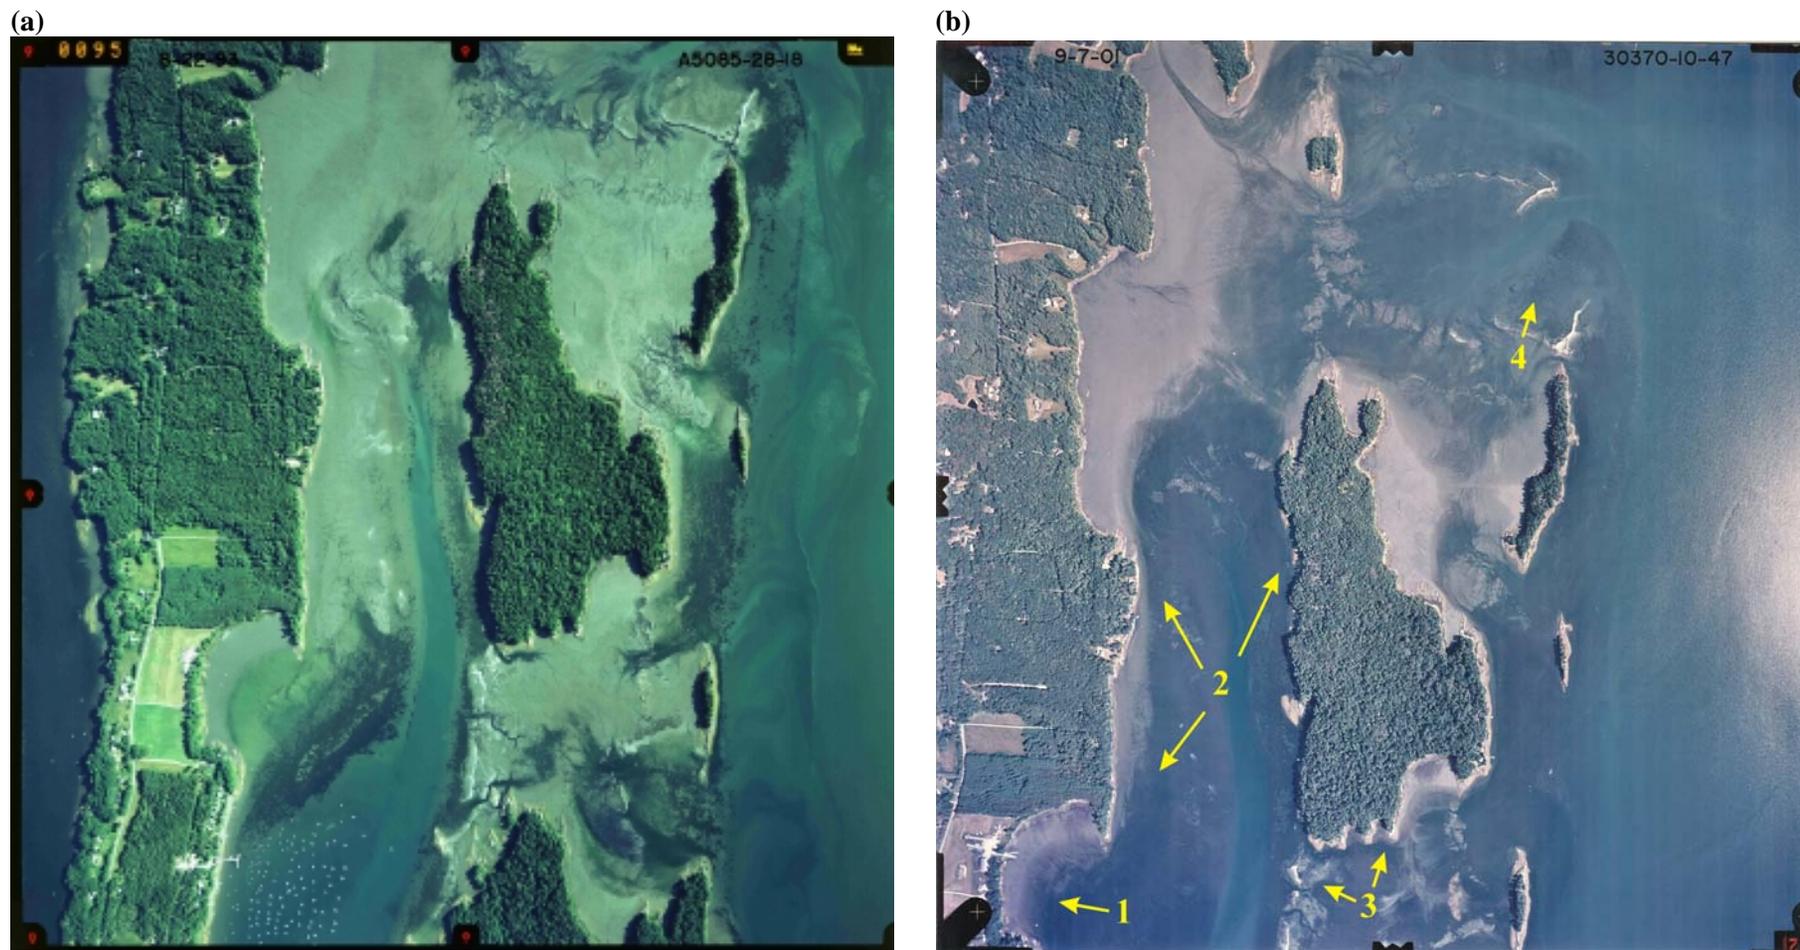
Figure 4 Aerial photos of upper half of Merepoint Bay taken in 1993 (a) and 2001 (b) showing extent of expansion of eelgrass over the period

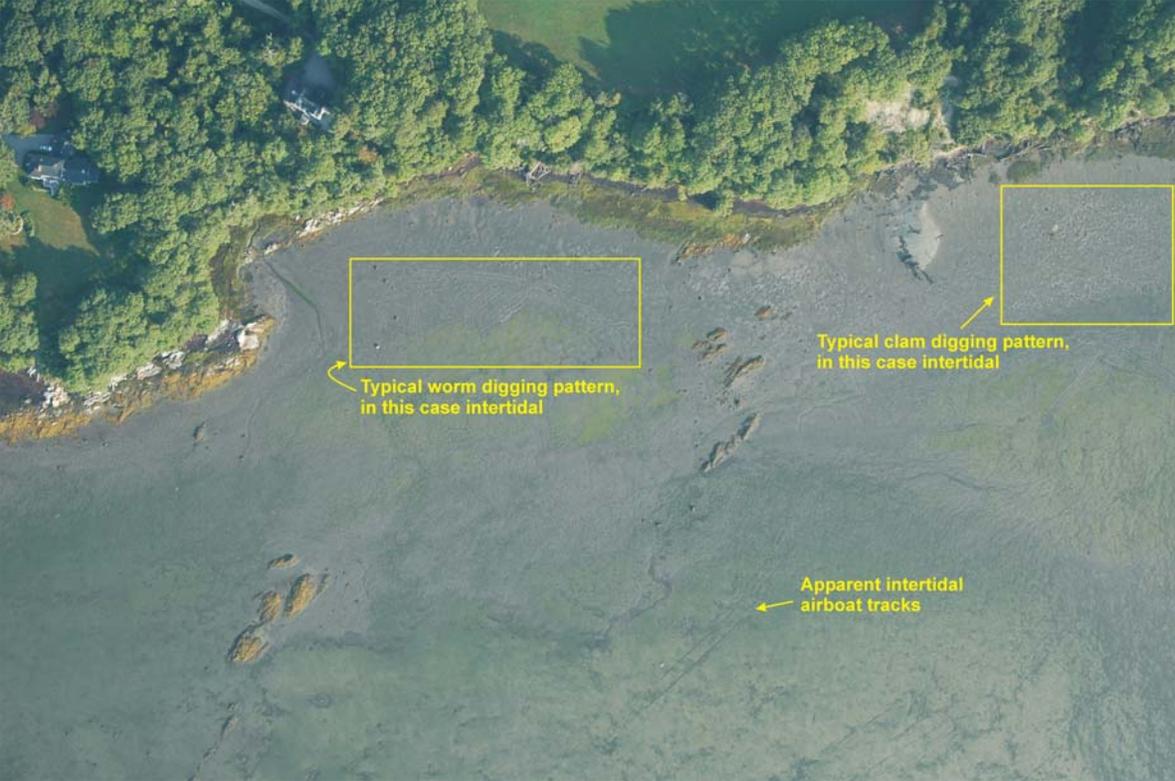
Clamming for soft-shell clams is primarily an intertidal fishery that takes place on mudflats. Occasionally soft-shell clams can be found in the lower extreme of the intertidal area, but rarely, if ever, in the subtidal where they are heavily preyed upon by crabs, primarily the green crab, *Carcinus maenas*. Clam harvesting results in a “turning” of the substrate that can potentially damage eelgrass through trampling, cutting, or uprooting. However, harvesting in the lower intertidal is limited and the potential for damage to eelgrass is similarly limited (pers. obs., C. Heinig).

Figure 5 Clam and worm harvesting patterns in intertidal area of Maquoit Bay, August 30, 2007

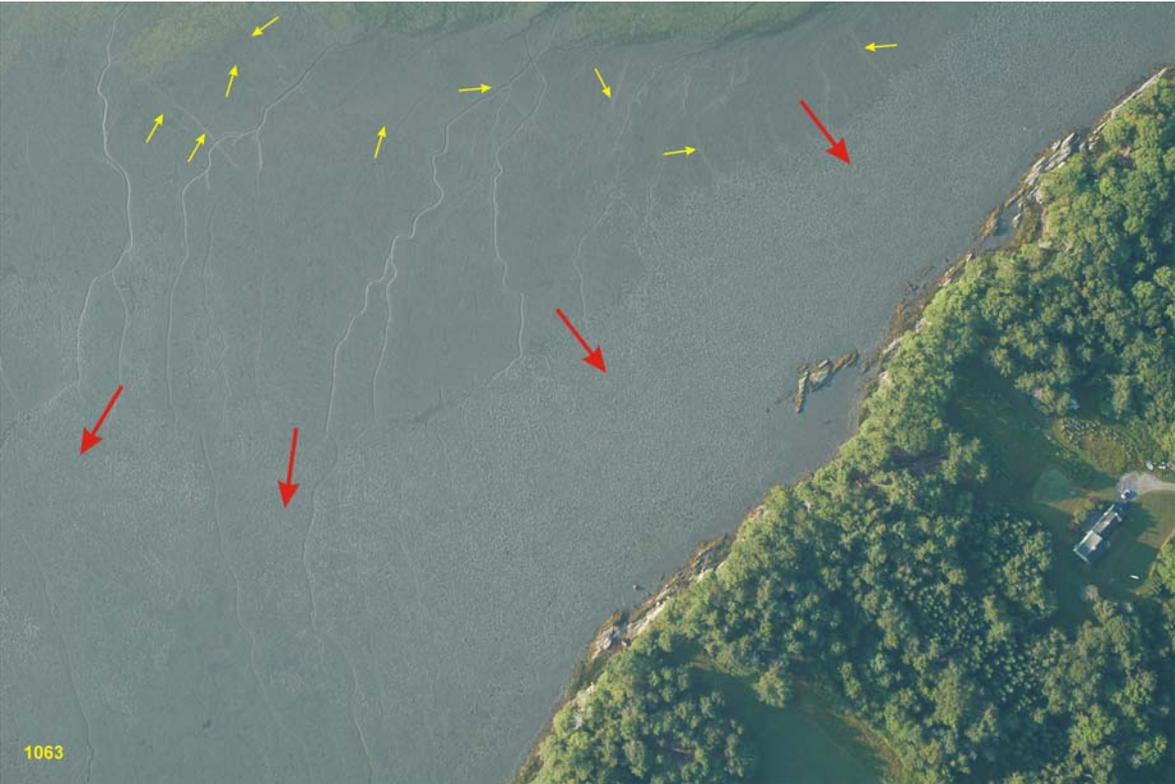
Blood worm and sand worm harvesting takes place in the intertidal area, but can extend into the extreme lower intertidal zone where eelgrass may be encountered. However, as with soft-shell clams, worm harvesting is only allowed using hand implements (12 MRSA §6771). Worm harvesting does take place in northern Casco Bay, but is extremely limited (pers. comm., Dan Devereaux, Brunswick Marine Warden). Worm harvesting is methodical and creates linearly symmetrical patterns as opposed to the more chaotic and unpredictable patterns of clam harvesting, both shown in Figure 5; propeller scars and clam harvesting patterns are shown in Figure 6.

Figure 6 Propeller scars (small yellow arrows) and clam harvesting patterns (larger red arrows) in intertidal area of Merepoint Bay, August 30, 2007

Propeller scars are visible within the intertidal and subtidal areas where damage to or removal of eelgrass is evident. Scars within the intertidal area appear to be caused by clam diggers arriving at flats between 2 to 3 hours before low water. In such cases, little impact to eelgrass would be anticipated since these are usually small aluminum boats in the 12-14 foot class powered by 15-25 hp outboards, many of them short-shafted, crossing the eelgrass well before low water; departure from the flats usually mirrors time of arrival, thus height of tide is usually similar.

Propeller damage is found primarily associated with floats where boats routinely arrive and depart over the same bottom. Propeller scars are found outside of these areas that are characteristically curved or hook-shaped indicating an apparent inadvertent intrusion into shallow water followed by an attempt to return to deeper water; such intrusions into shallow water are likely caused by boaters unfamiliar with the area. Although there are few discernable examples of such occurrences, as the number of boaters increases over time the number of such occurrences is also likely to increase. One possible way of avoiding such damage would be to install navigational aids along the sides of the main channels within northern Casco Bay to maintain boaters within channels and direct them away from eelgrass areas. The navigational aids would end at the end of the channel, which in most navigable waters indicates the end of a channel opening into deeper water, thus ending restrictions on direction of navigation. In this case, however, the end of the navigational aids would indicate little or no water ahead at low water and a yellow cautionary buoy might be installed in the middle of the end of the channel indicating "End of Channel".

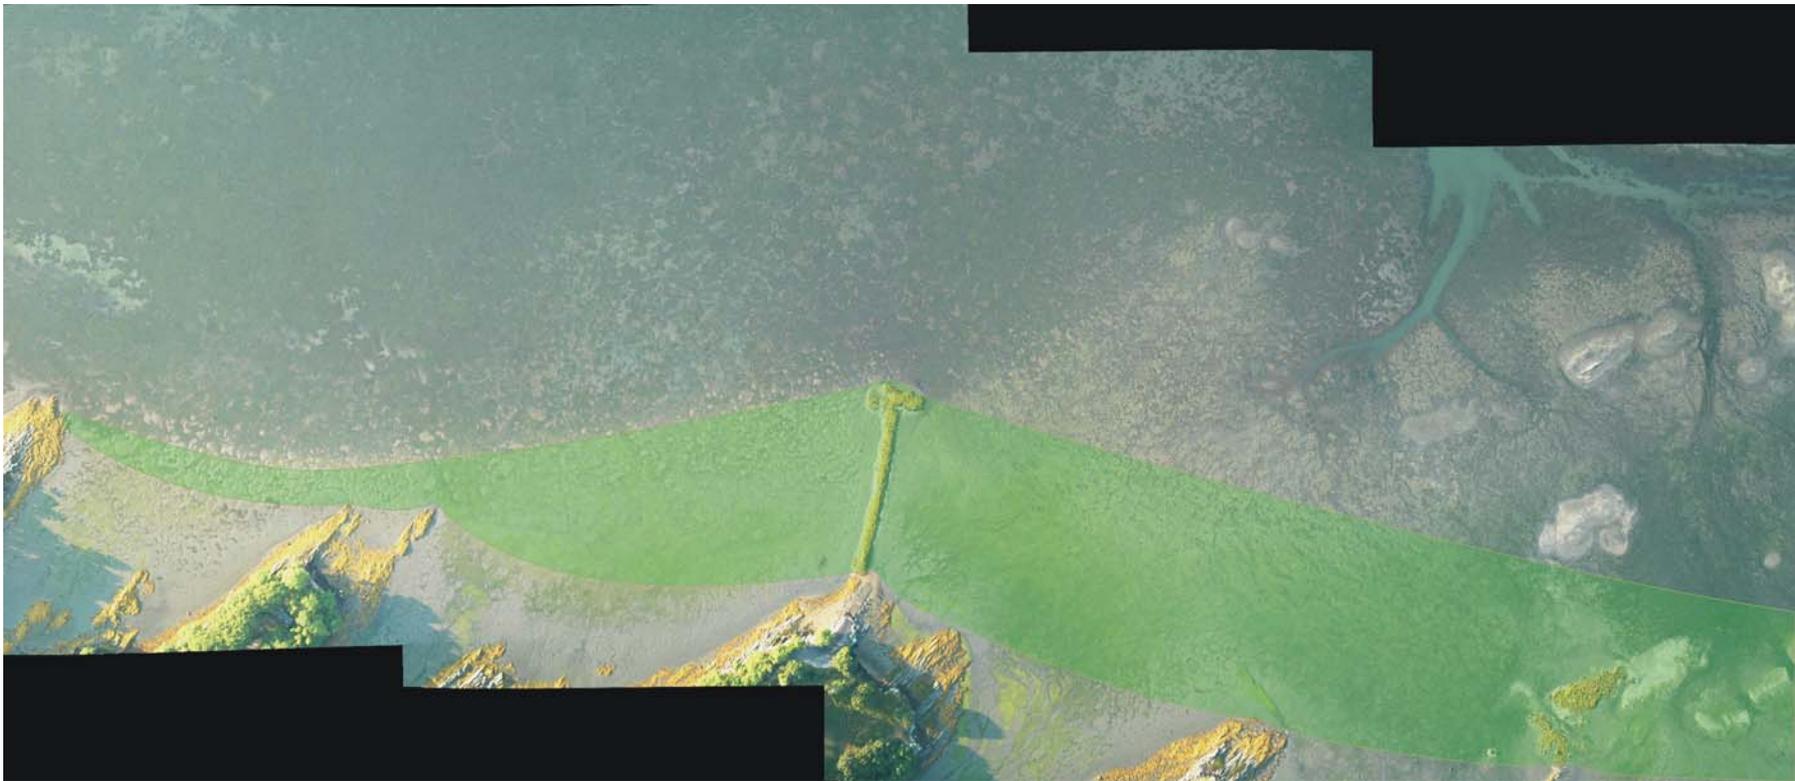
The largest man-made structure extending from the shoreline into the eelgrass habitat within northern Casco Bay is the stone pier at Simpson Point. The pier, or “wharf”, was constructed in 1899 and extends perpendicularly from shore approximately 400 feet (Brunswick Telegraph: June 21, 1899, p.3 Brief Notes). The article references the “new wharf” being built “out into the channel” suggesting that the waters off Simpson Point were deeper at the time and that sedimentation over the past 100+ years has caused the general uppermost area of Merepoint Bay to become shallower.

Based on the eelgrass distribution pattern along the shoreline adjacent to, but beyond the influence of, the stone pier it is estimated that more than 800,000 ft² or 18 acres of eelgrass habitat might be created if the stone structure were removed and the surrounding area were to become revegetated with eelgrass (see Figure 7). Furthermore, it is also difficult to determine if the lack of eelgrass around the structure today is due to sedimentation around the stone pier that, over time, has raised the seafloor to the point that it is no longer suitable as eelgrass habitat. If so, removal of the stone pier by itself may not be sufficient to insure reoccupation of the area by eelgrass; additional removal of sediment may be required if tidal currents alone fail to return the area to its former depth. Clearly, additional work would need to be done to provide high-resolution bathymetry of the area surrounding the pier and the hydrodynamics of the area would need to be studied to develop the necessary models to predict sediment redistribution within the area following removal of the pier.

Figure 7 Stone pier at Simpson Point showing possible eelgrass coverage (green overlay) following removal of the structure.

Although the stone pier is admittedly a man-made structure, since it has been in place for 100+ years, the intertidal hard substrate provided by the structure constitutes habitat for flora and fauna requiring such substrate. Therefore, removal of the structure would ultimately result in the substitution of one habitat (shallow subtidal soft-bottom, eelgrass) for another (intertidal hard-rockweed habitat) and a decision to move forward with such a project would require a habitat-value judgment to be made.

Removal of the pier is undoubtedly technically feasible; however, the total financial cost of removal, including pre-removal studies, project permitting, physical removal, and follow-up monitoring of effectiveness would be substantial. Additionally, although temporary, there would likely be an environmental cost associated with the disturbance created during the removal process, all of which would need to be considered during project planning.

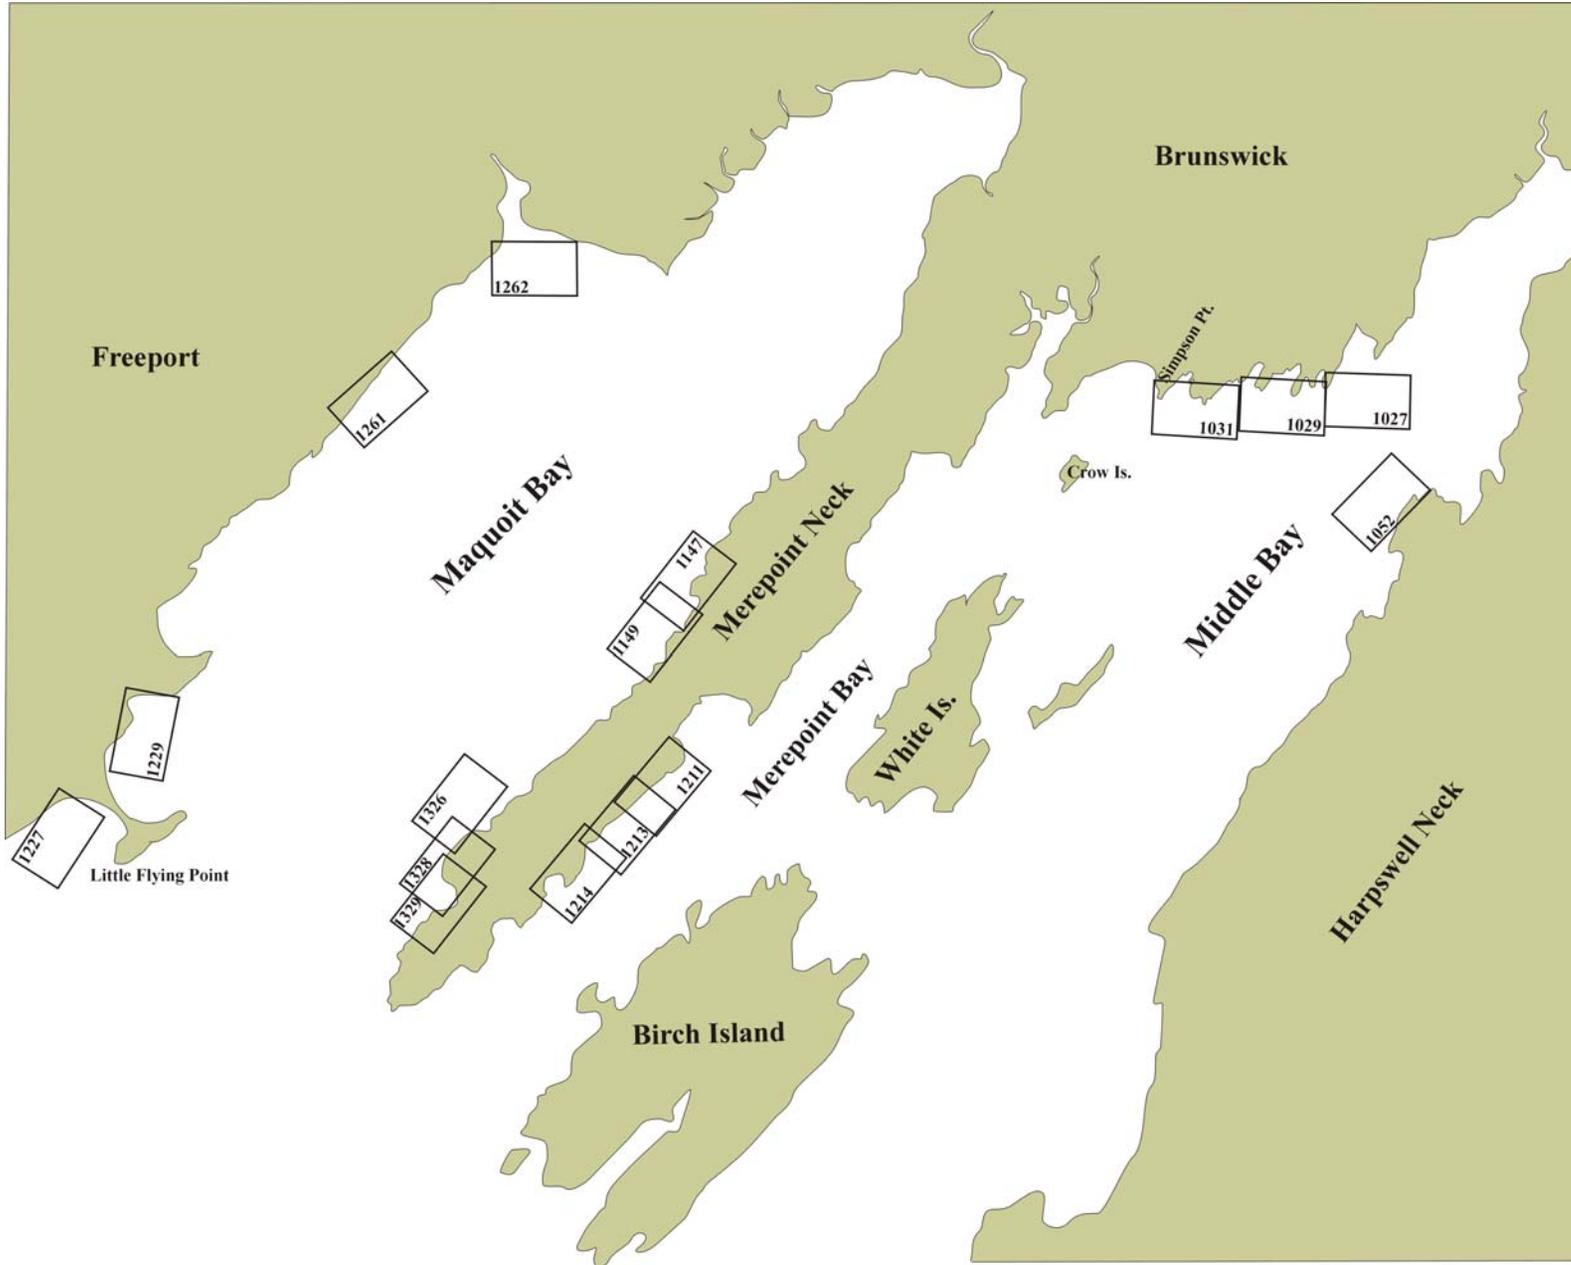
Guide to location of aerial photos used in physical disturbance analysis (does not include full set of aerial photos taken)
